STRUCTURE AUDIT REPORT

**Rayat Shikshan Sanstha's
Karmaveer Bhaurao Patil College of Engineering, Satara**

DATE: 06/04/2023

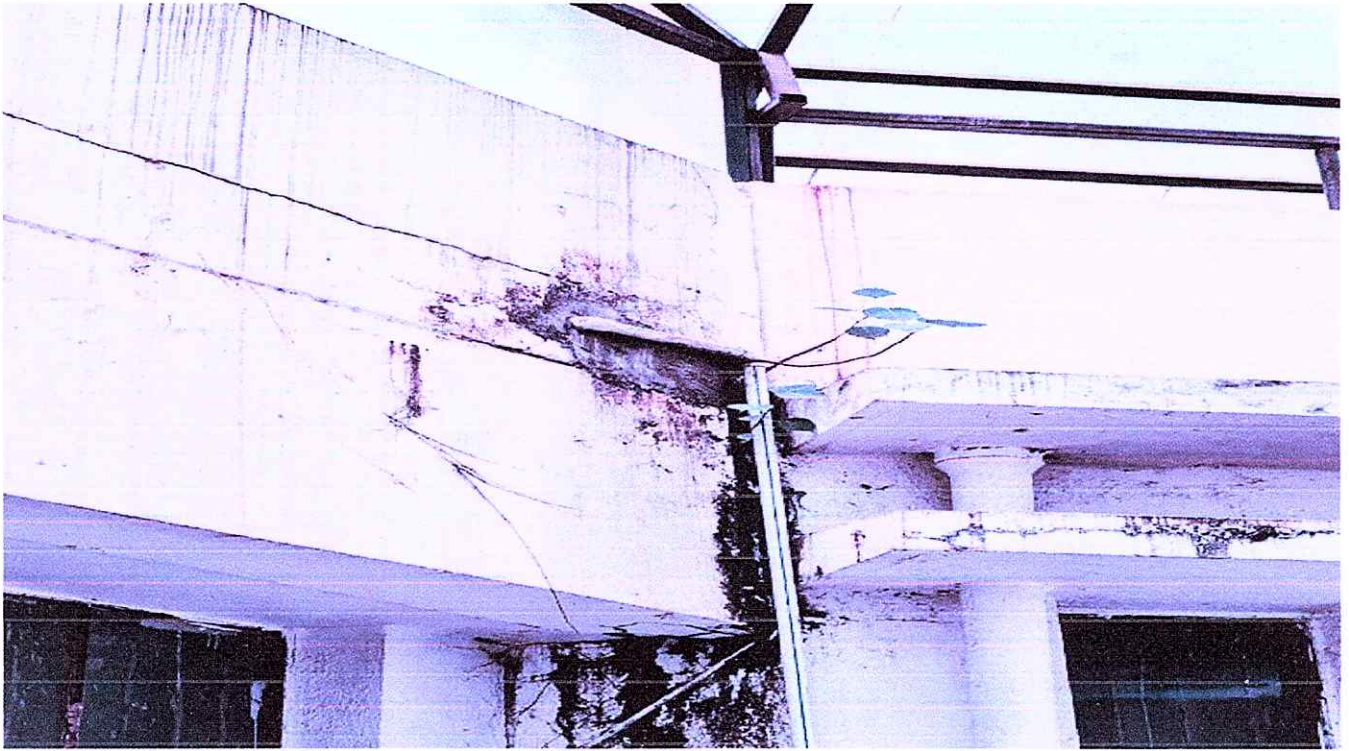
6. At some places vegetation is occurred need to be removed to avoid future distress in the concrete.

Vegetation Observed to parapet wall at open space in front of Library

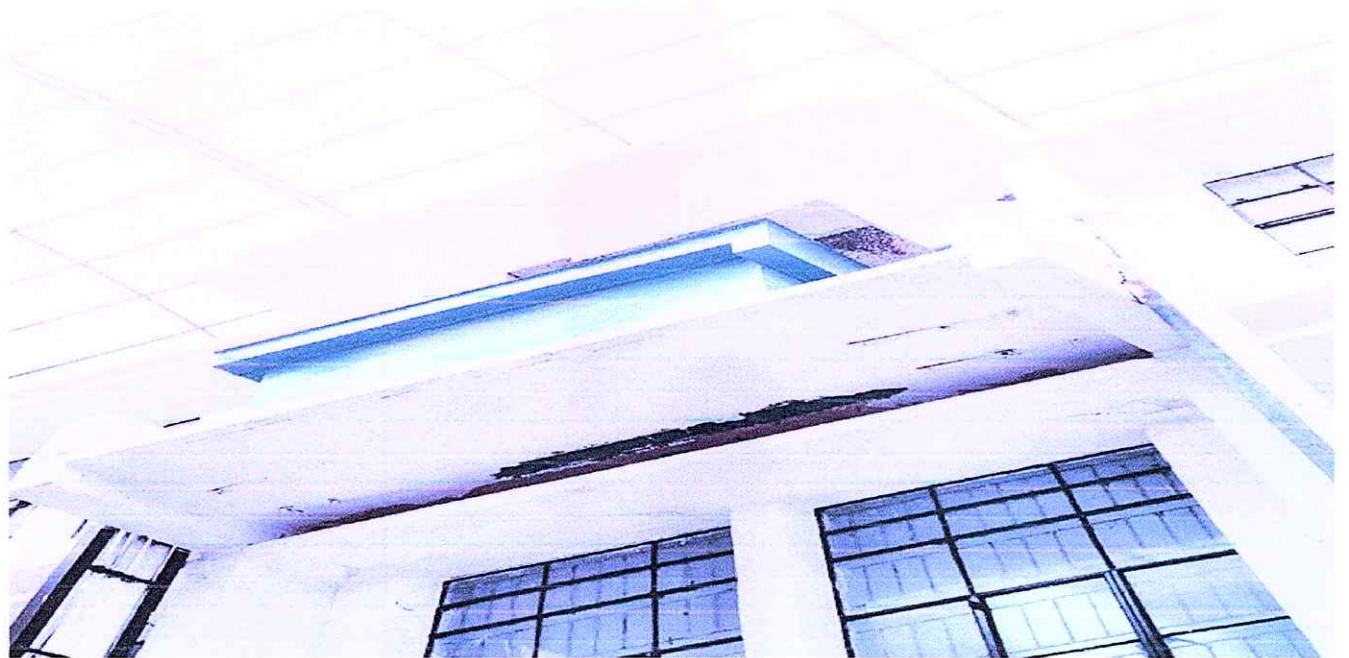
5. The slab below water tank in front library which is not mentioned in architectural plan but in exist has severe damage such as spalling of concrete and steel getting corroded which is in very bad condition and has to be repaired immediately.

Major Repairs work required for cantilever slab below water tank in front of Library

1. For repairs to RCC members under distress like beams, slabs, columns, chajjas from inside and outside, we recommend the following :
 - a. Remove all the loose rust of reinforcement by hammering and cleaning the rusted surface by stiff wire brush.

- b. Remove the residual rust by applying rust remover with cotton waste swab. Allow the solution to remain for at least 24 hrs. and then brush off the loose particles of any by means of the brush .

- c. Apply rust passivator in two coats to reinforcement which acts as rust preventor in intervals of 4 hrs. Between 2 coats.
 - d. Apply Polymer Modified mortar in 1:5:15 and make up the cover concrete to RCC member and cured for min. 3 days.

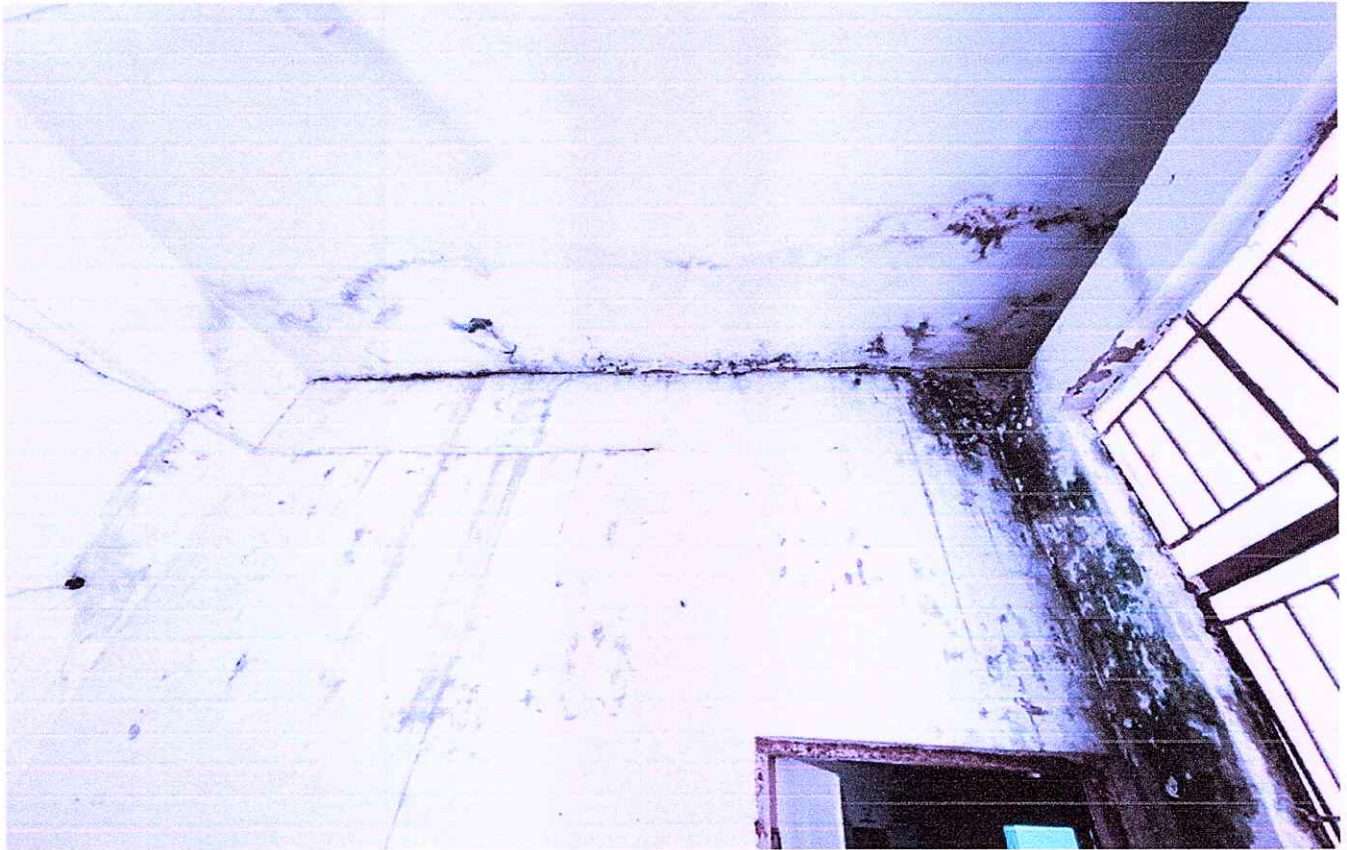
2. In Chemistry Lab faculty room where reinforcement is exposed in slab/ceiling. There are cracks in ceiling and loose plaster shows signs of deterioration and debonding from parent concrete.

Major leakages has been observed on second floor at Chemistry lab where contact between slab and beam has been lost
